PHOTOGRAPHIC INTELLIGENCE REPORT

MILITARY COMPLEXES,

MENG-TZU AND WEN-SHAN,

CIA/PIR 77082

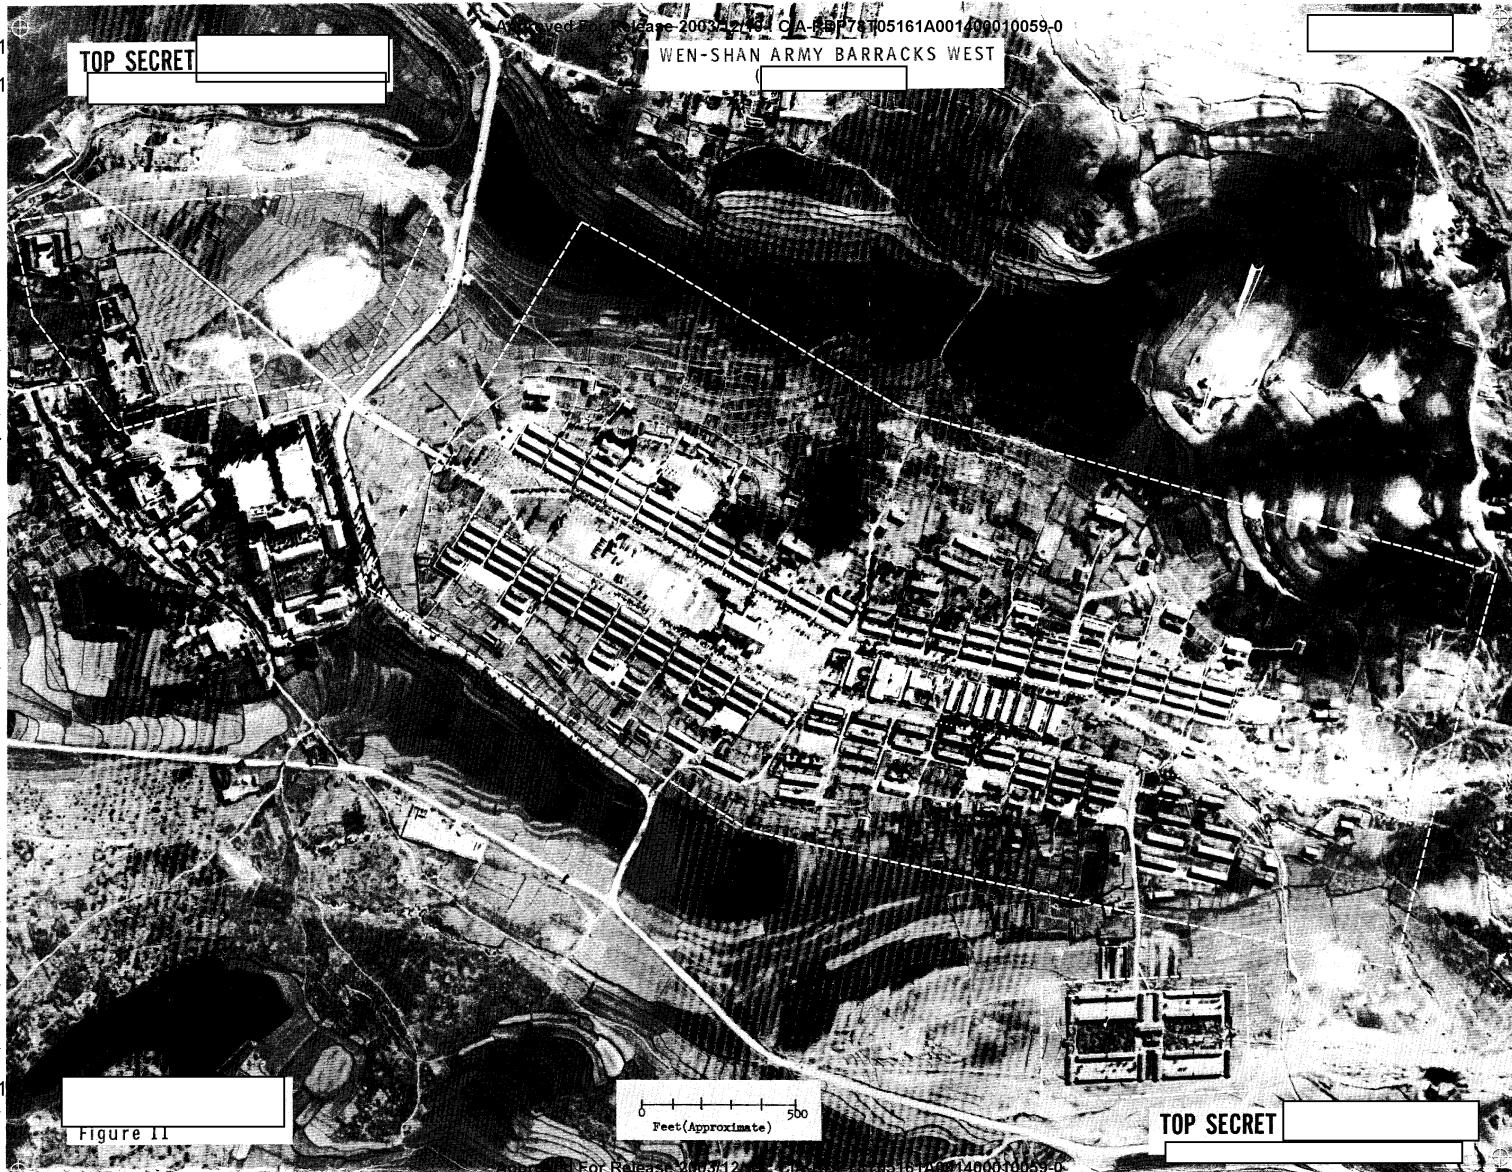
Figure 11

The Wen-shan Army Barracks West is located 1.0 nm west of Wen-shan (See Figures 10 and 11).

No significant changes in facilities have been observed since  
[redacted] coverage.

WEN-SHAN ARMY BARRACKS WEST

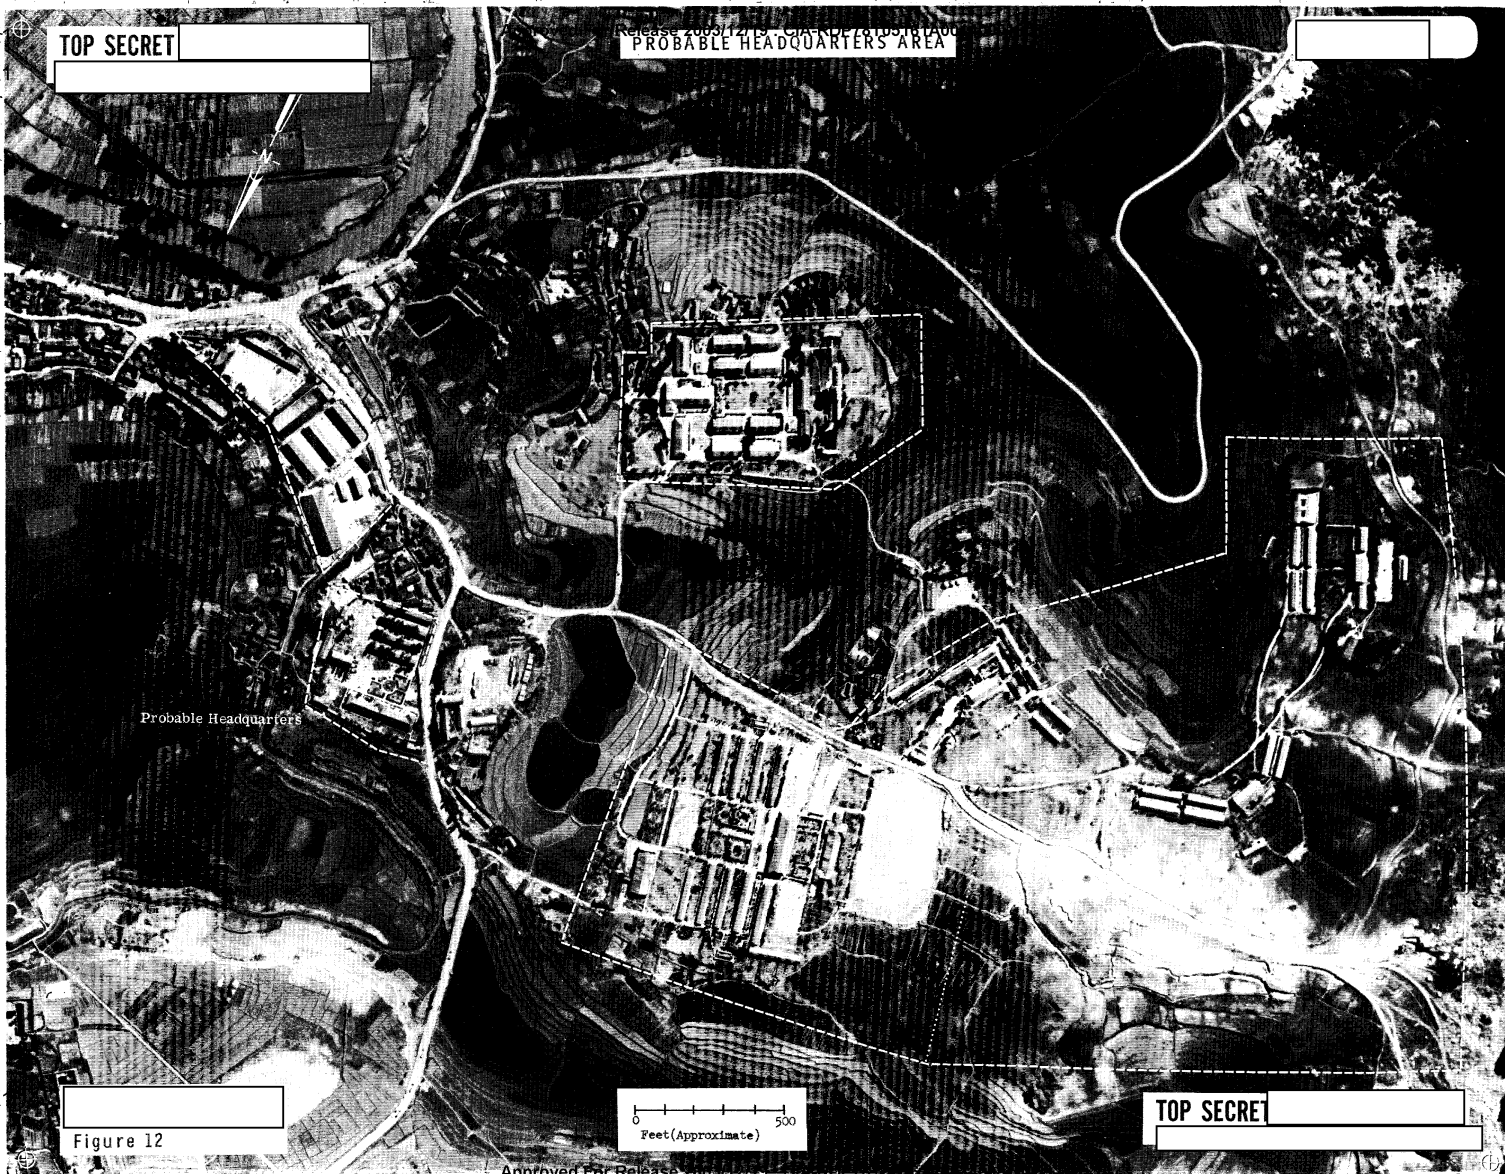
Figure 12

The probable headquarters area is located on the west edge of Wen-shan (See Figures 10 and 12).

This installation is divided into five areas with Areas A and C being the probable headquarters and headquarters barracks areas respectively. Areas B, D and E are the associated facilities of the probable headquarters complex.

No significant changes in facilities have been observed since [redacted] coverage. Obliquity of earlier coverage precluded interpretation.

Release 2003/12/19 : CIA-RDP78-10516TA0001-0  
PROBABLE HEADQUARTERS' AREA
